Assessing the fate of returning upper Yukon River Chinook salmon (2017-2020)

William M. Twardek^{1,2}, Nicolas W.R. Lapointe², and Steven J. Cooke¹

Published May 18, 2021

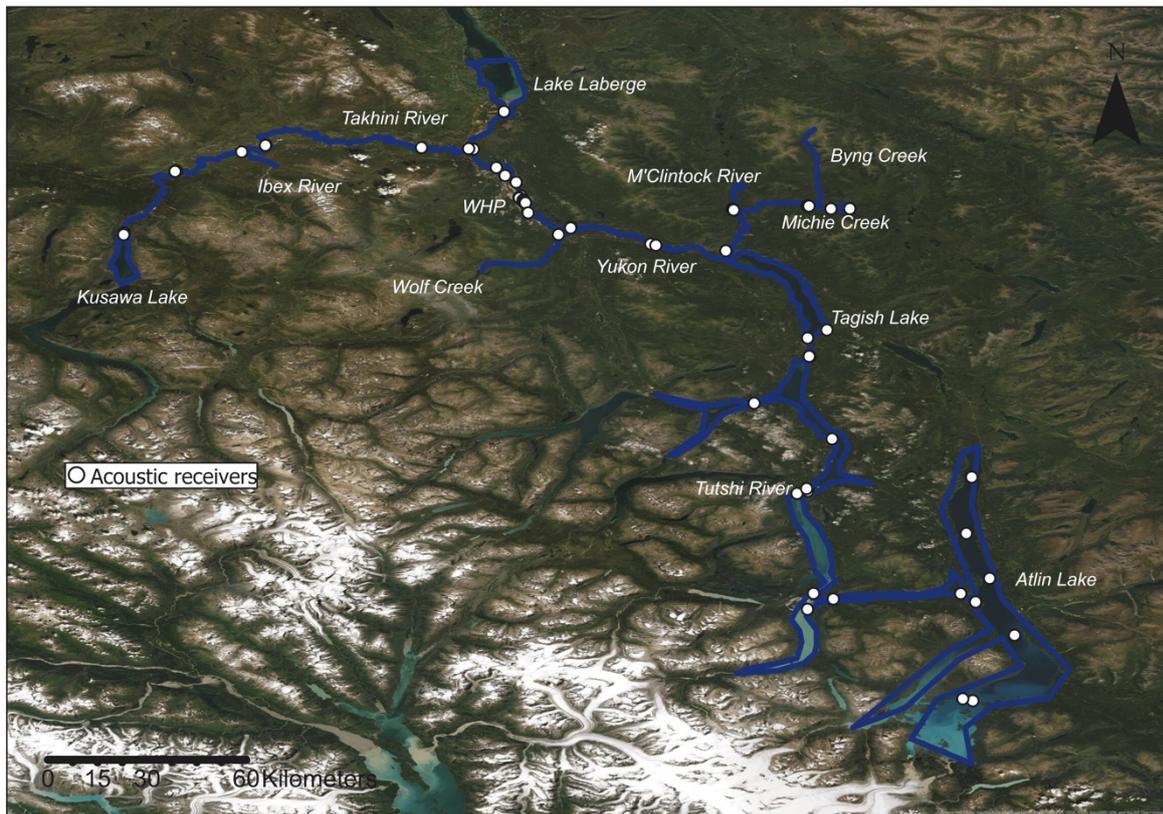
Figure 1. The acoustic and radio receiver array deployed throughout the Yukon and Takhini rivers upstream of Lake Laberge from 2017-2020. Note that receivers in Tagish and Atlin Lake were deployed by Environment Yukon and the BC. Ministry of Forests, Lands and Natural Resource Operations. Receiver locations changed over the course of the project such that not all locations shown above were monitored for all four years.

Between twenty (2017) and thirty nine (2020) Vemco VR2W receivers were deployed between the confluence of the Yukon and Takhini Rivers and Michie Lake as well as the Takhini River (Figure 1). Acoustic receivers were generally anchored with a cement block or sand bag and were tethered to a rope extending up to a sub-surface buoy. Receivers were tested prior to deployment and a subset of receivers were range tested. Range testing was completed in 2018 and 2020 at each site by placing a V16 or V13 range test transmitter at set distances from each receiver for a set time interval (generally 12 minutes or 100 potential detections). Range test results are presented in Appendix 1. Detection efficiency of acoustic receivers around the WHP was low in 2017 and 2018 (Appendix 2), so radio receivers were deployed instead of acoustic receivers given their higher performance in acoustically complex environments. Range testing was completed on these receivers to confirm their function, and gain was set such that the entrance receiver could only detect tagged salmon outside the ladder (87% efficiency at 2.5 m from the entrance). Additionally, Chinook salmon movement was monitored beyond Marsh Lake and into the Southern Lakes by the 20-receiver array maintained by Environment Yukon for a concurrent Lake Trout (*Salvelinus namaycush*) study (Figure 1).

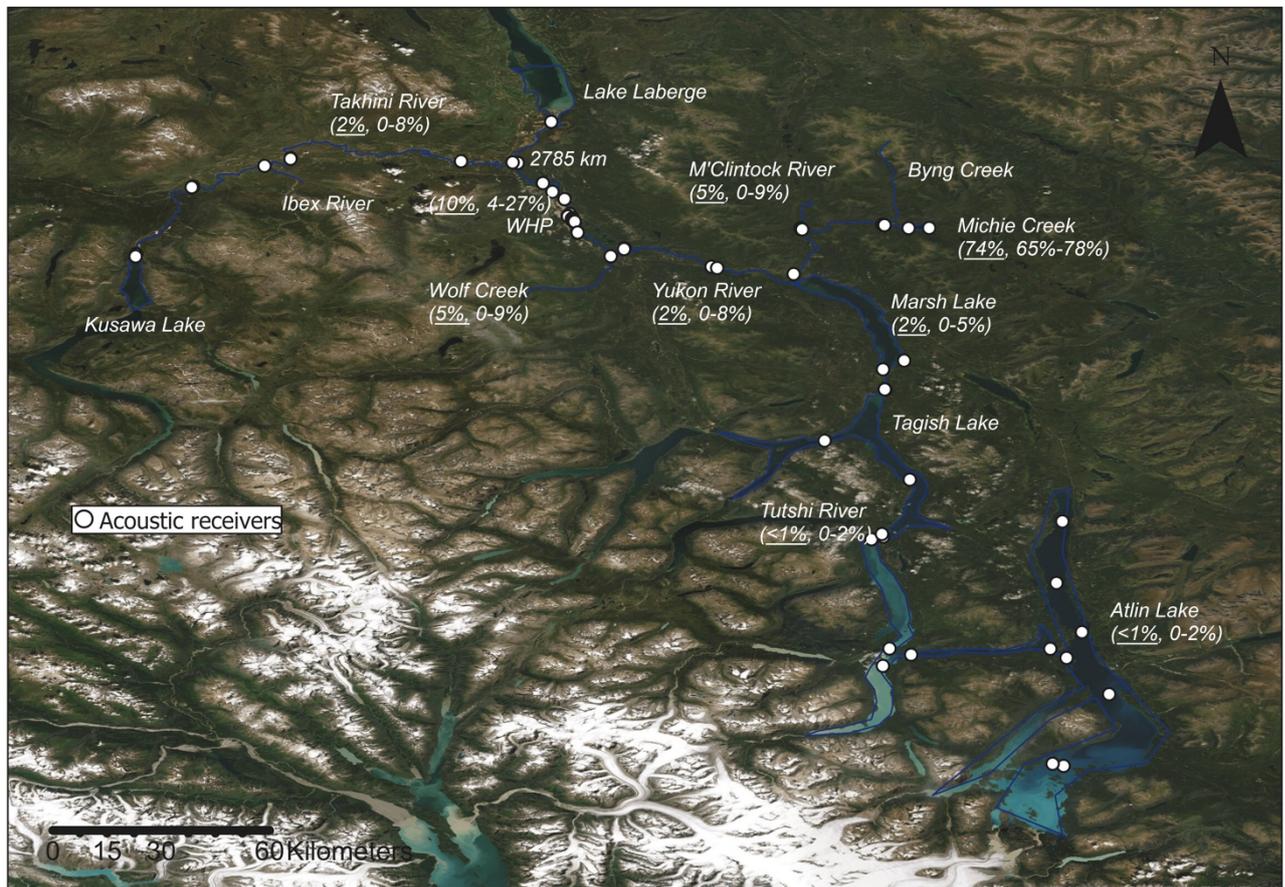
Figure 2. The terminal reaches of tagged Chinook Salmon (assigned as the reach between adjacent receivers) that passed the Whitehorse Rapids Fishladder from 2017-2020. Data are presented as (4 year mean, range of annual means).

Michie Creek is the primary spawning tributary for Chinook salmon upstream of Whitehorse, YT with 74% of all tagged salmon passing the WHP terminating in that system (Figure 2). Most of the tagged salmon entering the Michie Creek-M'Clintock River system terminated in Michie Creek upstream of Byng Creek (55%) while 38% terminated in Michie Creek between Byng Creek and the M'Clintock River,

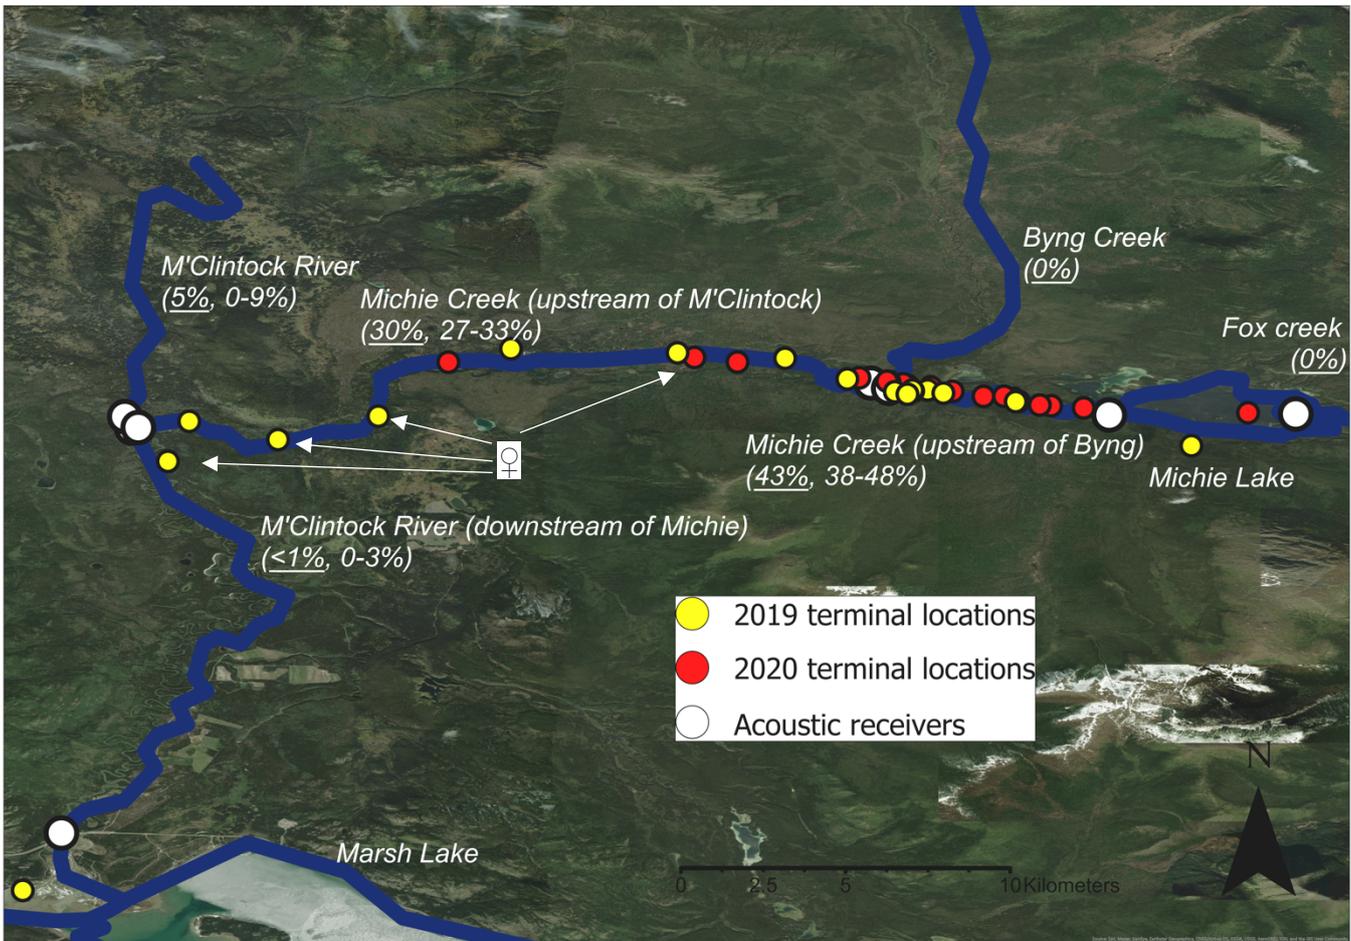
Figure 3. The terminal reaches of tagged Chinook Salmon in Michie Creek in 2019 and 2020. Data are presented as the proportion of all tagged salmon passing the WHP that terminate in each reach (4 year mean, range of annual means).

though many of these salmon first reached the confluence of Byng Creek and Michie Creek, and terminated just downstream of this confluence. Nonetheless, it was common for both male and female tagged salmon to terminate throughout the entirety of the creek. Finer scale terminal locations of fish in Michie Creek were determined by manual radio tracking on foot and in a Cessna 206 (Figure 3; Appendix 3, 4).

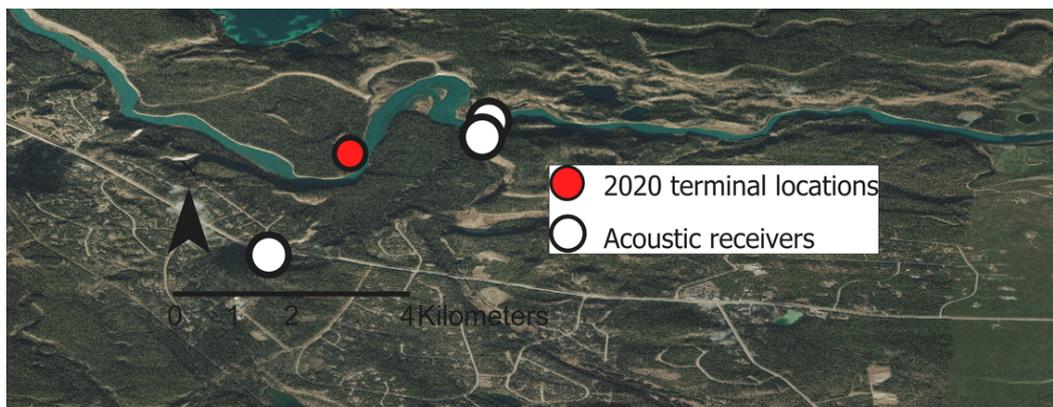
Figure 4. Terminal location of a wild Chinook Salmon female that was recovered as a completely spawned carcass in the Yukon River downstream of Wolf Creek in 2020.

Over the course of 4 years, three salmon (2%) terminated in the mainstem Yukon River upstream of the Whitehorse Hydro Plant. One of these tagged salmon (a female) was recovered in 2020 as a completely spawned carcass downstream of Wolf Creek, providing strong evidence for successful spawning in this area (Figure 4).

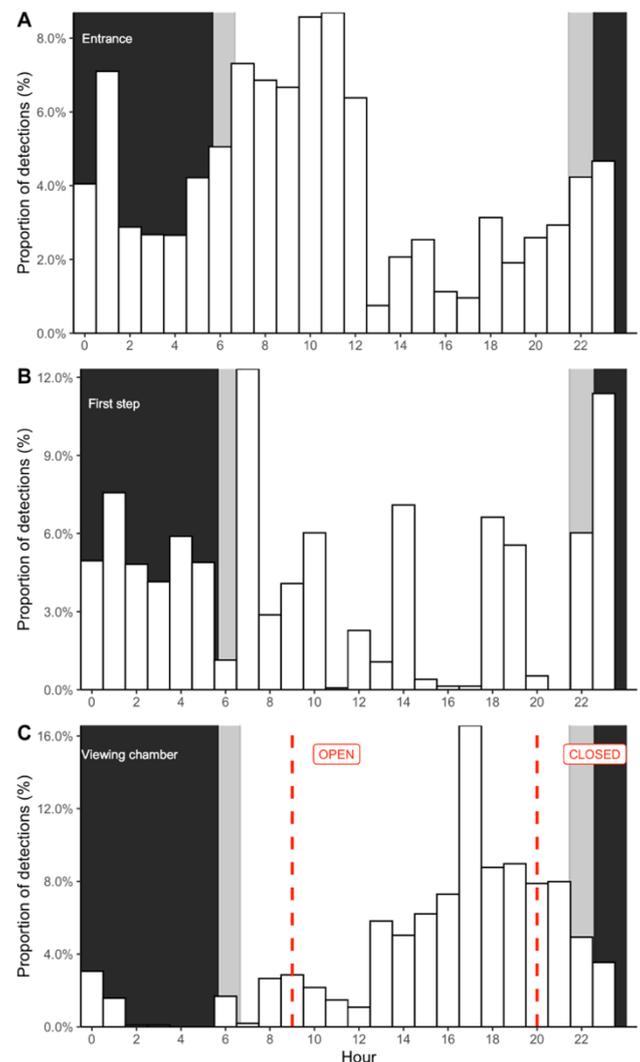
Figure 5. Diel ladder use of Yukon River Chinook Salmon measured as the proportion of all detections at A) the ladder entrance ($n=10846$) B) the first step of the ladder ($n=1494$) and C) the ladder viewing chamber ($n=1014$) over a diel period. Constant nighttime hours are shown in black while grey areas reflect the shifting sunrise and sunset times over the course of the migration. Red lines indicate the opening and closing hours for the ladder viewing chamber. Data were combined for all years (2017-2020).

Salmon spent time at various sections of the fishway both during the day and at night, with the majority of detections occurring during day light (Figure 5). Of greater relevance to this fishway is whether salmon first arrived at the viewing chamber during hours of operation (9:00-20:00) or during close (when passage through the fishway is impossible). Indeed, more than half of all salmon arrived at the viewing chamber for the first time when the facility was closed (53%; $n=17$), and 34% of overall detections in the viewing chamber occurred during closed hours (Figure 5). Salmon that failed to pass the viewing chamber, spent more time attempting passage at the viewing chamber (50.6 [4-121] h; median = 30.9 h; $n=5$) than salmon that passed the viewing chamber (18.8 [0.1-105] h; median = 1.7 h; $n=11$; $t=-1.59$, $P=0.14$). Salmon that failed to pass typically also entered the chamber during daylight hours when passage should be permitted, though the upstream chamber gate can often remain closed during the day to permit counting, and adult collection for the hatchery.
